Stair Seminar

**Balancing High Standards of
Specification with Innovative
Design**

28th March 2012

The Performance in Fire of Escape Stairs Background to LPCB/BWF Fire Protected Timber Stair Scheme

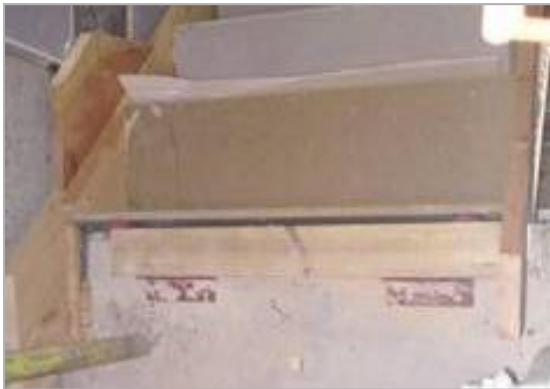
- *String cut over trimmer and securely fixed.*

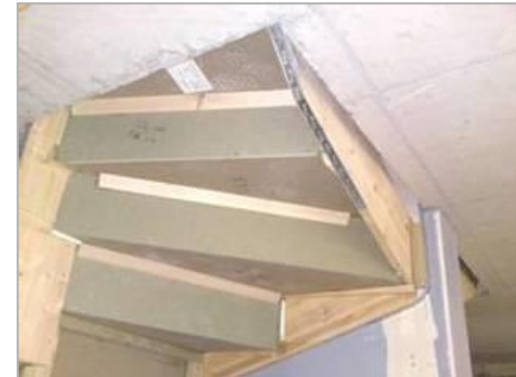
- *Steel straps supporting under strings where required*

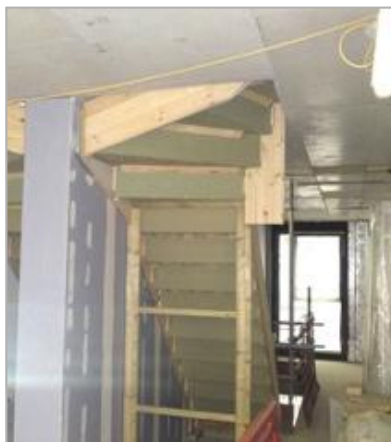
- *Trunk fully supported in accordance with manufacturer's instructions*

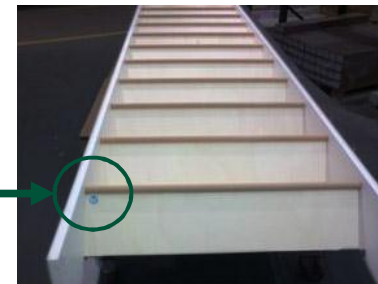
2. On front of bottom riser top left hand side

“ And in “no newel post” situation

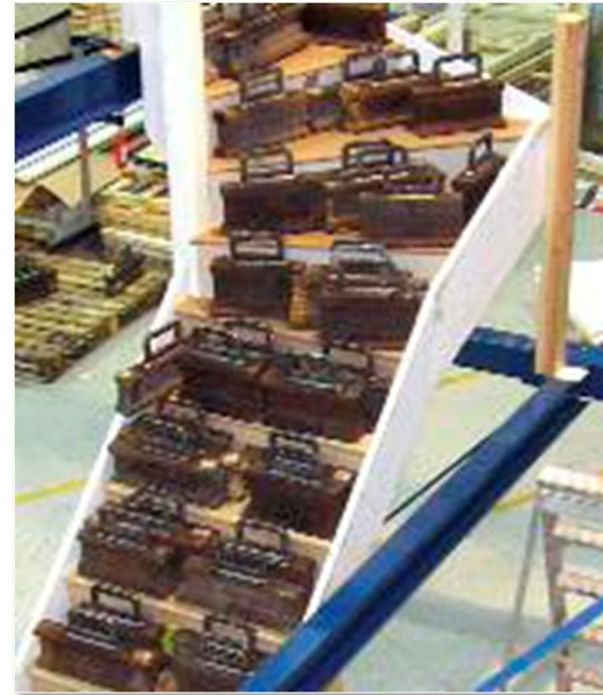
Mechanical Testing of Stairs

- Key requirements
- Loading
- Domestic
- Common flights
- Deflection
- Evidence of structural integrity
- Includes trunk and balustrading
- May include demountable balustrade

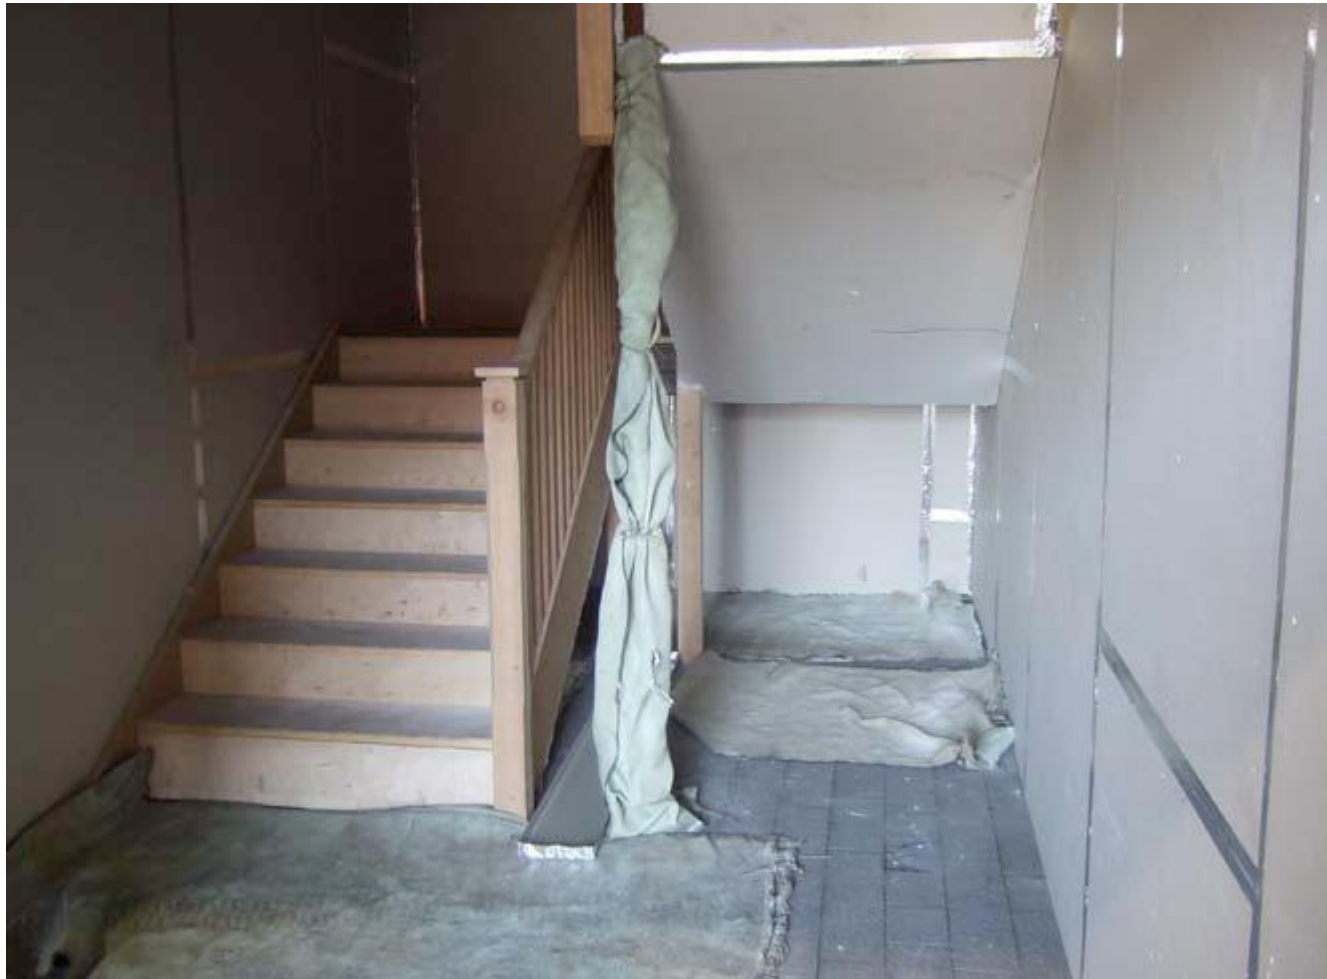
CLG Experimental Programme

- . 13 Fire tests completed. Principal conclusions were:
- . Unprotected timber stairs are incapable of surviving the design fire scenario
- . A return flight with intermediate landing (dog leg) provides a worst case in terms of fire spread
- . A straight flight stair provides a worst case in terms of structural stability (post-fire)
- . A range of different design solutions (brush applied intumescent coatings, pressure impregnated treatments, fire retardant MDF) have demonstrated their ability to survive the fire scenario and continue to perform their design function
- . The inclusion of stair coverings did not adversely affect the performance of the stair

Test no.	Stair geometry	Timber type/species Treads and Risers	Treatment process	stair covering	Results Reaction to fire test	Results post-fire load test	Comments
1	dog-leg	Whitewood	Unprotected	none	failed	n/a	test terminated after 3 minutes
2	straight flight	Whitewood	Unprotected	none	failed	n/a	test terminated after 16 minutes
3	dog-leg	MDF	Unprotected	none	failed	n/a	test terminated after 3 minutes
4	dog-leg	Whitewood	surface treatment (intumescent)	none	passed	passed	no significant damage observed
5	dog-leg	MDF	surface treatment (intumescent)	none	passed	passed	no significant damage observed
6	dog-leg	Whitewood	pressure impregnation (Class 1)	none	passed	passed	risers burnt through
7	dog-leg	Whitewood	pressure impregnation (Class 1)	carpet (wool) with rubber underlay	passed	passed	no significant damage observed
8	straight flight	Whitewood	pressure impregnation (Class 1)	none	passed	passed	risers burnt through, stair unsafe for use after completion of load test

9	dog-leg	MDF	pressure impregnation (Class 1)	carpet (wool) with rubber underlay	passed	passed	no significant damage
10	Straight flight	MDF	pressure impregnation (Class 1)	none	passed	passed	no significant damage
11	dog-leg	MDF	pressure impregnation (Class 0)	none	passed	passed	no significant damage
12	dog-leg	MDF	pressure impregnation (Class 0)	carpet (polypropylene) with rubber underlay	passed	passed	no significant damage
13	dog-leg	Whitewood	pressure impregnation (Class 0)	none	passed	passed	no significant damage

Table 1 Summary of experimental programme
